EKSPERIMENTALNA ISPITIVANJA SKALIRANOG MODELA I SEGMENTA LUKA STAROG MOSTA U MOSTARU

Mladen Kustura, Ph.D.

EXPERIMENTAL TESTING OF SCALED MODEL AND ARCH SEGMENTS OF THE OLD BRIDGE IN MOSTAR

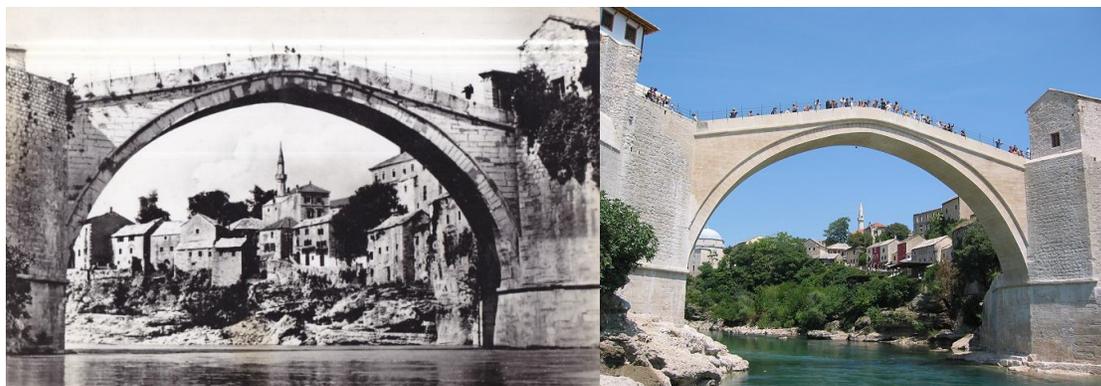
a) b)
Figure 1. The Old Bridge and the reconstructed "new" Old Bridge

Although over the centuries the bridge (Figure 1.-a) was exposed to various influences, both to elements and its very use, more serious repair measures or similar interventions were not recorded in archives until 1952, when an inspection established that it was necessary to carry out repair of the worn-out wooden floor structure on bridge towers. Also, it was proposed to remove vegetation from the bridge walls, which was the cause of the occurrence of cracks on them. In the period from 1954 to 1957, the bridge foundations and the river banks were rehabilitated. In 1963, by then the most comprehensive bridge repair was carried out by grouting the bridge arch and replacing damaged stone blocks. In addition to archaeological explorations of the site, detailed photogrammetric survey of the entire structure was carried out in 1982. The Old Bridge was demolished in 1993, and after the reconstruction which was completed in 2004 (Figure 1.-b), the new Old Bridge was registered in the UNESCO List of Protected Cultural Monuments.

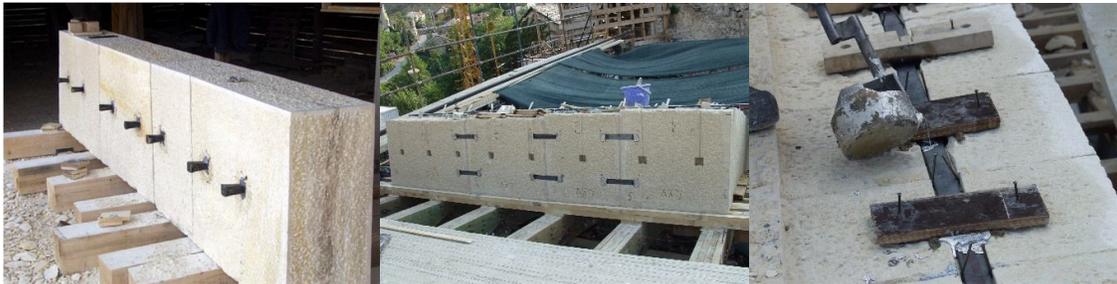
Figure 2. Details of bridge arch assembling

Stone elements of the bridge were reinforced by using fixings hand-made of wrought iron and placed over connecting joints. These iron connectors, or cramps and dowels, were essentially applied on stone elements with purposely carved slots with slightly wider bottom to avoid making it completely airtight. The connectors also had wider edges, and after they were fixed, liquid lead was poured into the slots to complete the assembly (Figure 2).

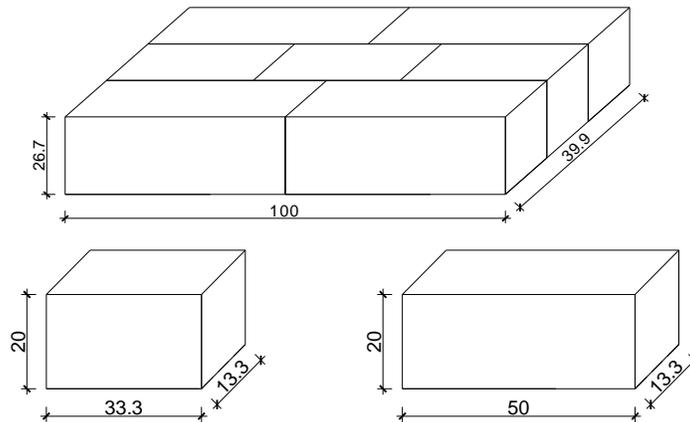
Figure 3. Dimensions of test segments

1:3 and their quasi-static testing in the laboratory. The geometry of arch segments produced in accordance with the adopted scale is shown in Figure 3. The aim of this stage of research was to establish the bearing capacity of all connection elements subjected to possible loads occurring in the vault of the bearing arch, as well as the way in which the loss of connection and bearing capacity occurs in stone masonry.

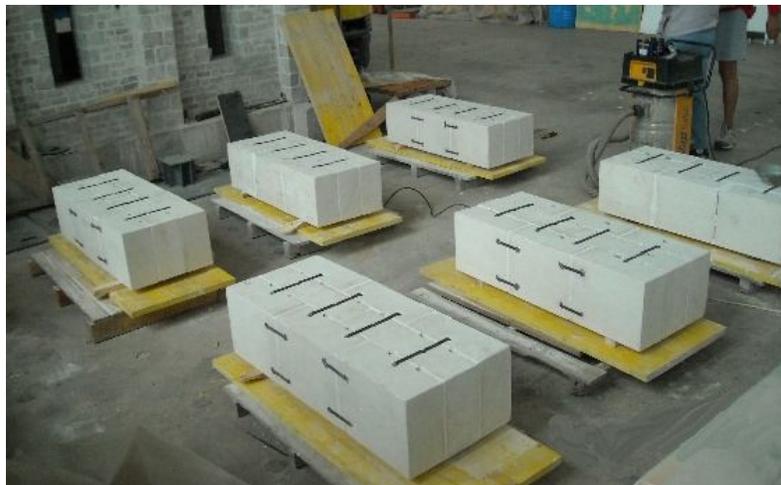
Figure 4. Produced arch segment models

The prepared segments, shown in Figure 4, were examined by testing two sets at a time with the same load application principle in order to determine their load-bearing capacity under the given load. Depending on the position of the tested element, the results were obtained that describe the behavior under bending load for two different ways of orientation of the tested elements and the behavior during shear loading. Figure 5 shows how test segments were set in the testing position.

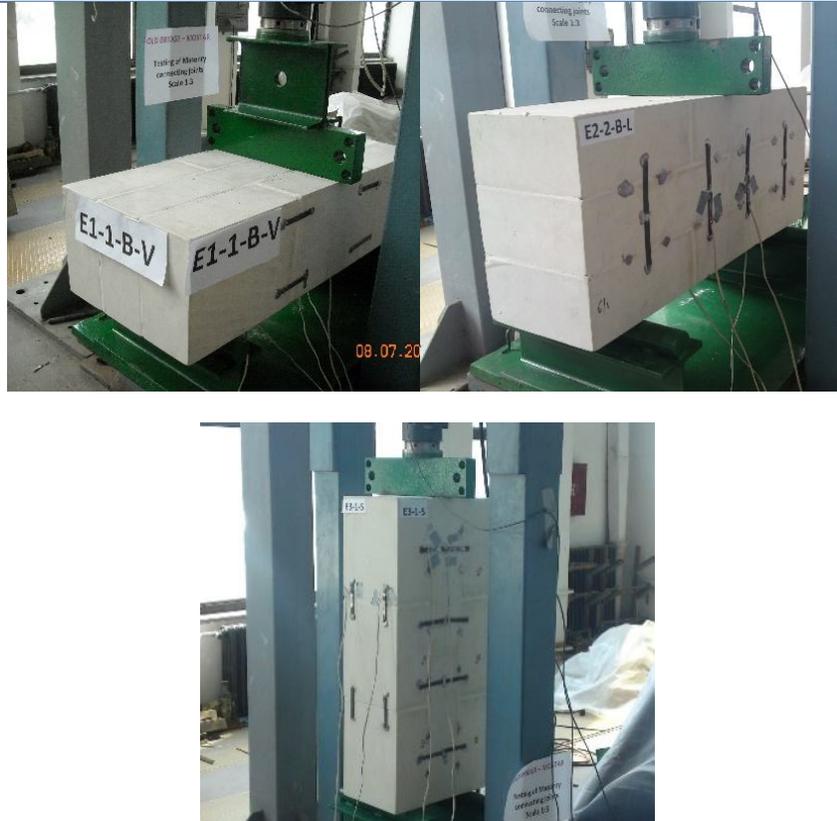
Figure 5. Constructed masonry segments placed in position for testing

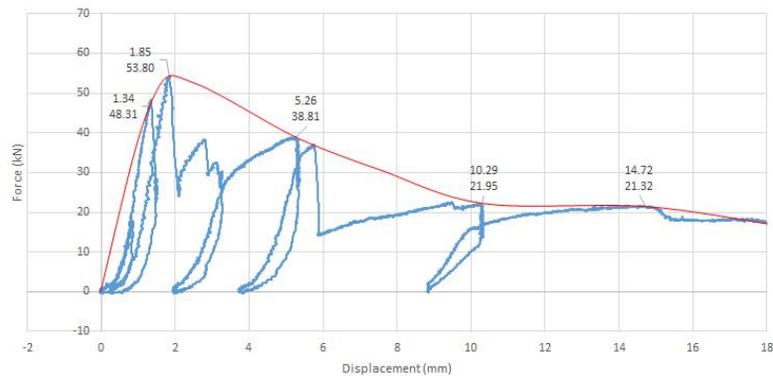
Figure 6. The force-displacement graph of the tested segment E1-1-B-V

The following figures show the force-displacement graphs for segments tested for bending - type 1 (Figure 6), bending - type 2 (Figure 7) and shear (Figure 8). The force-displacement graphs obtained for other tested segments have a similar form.

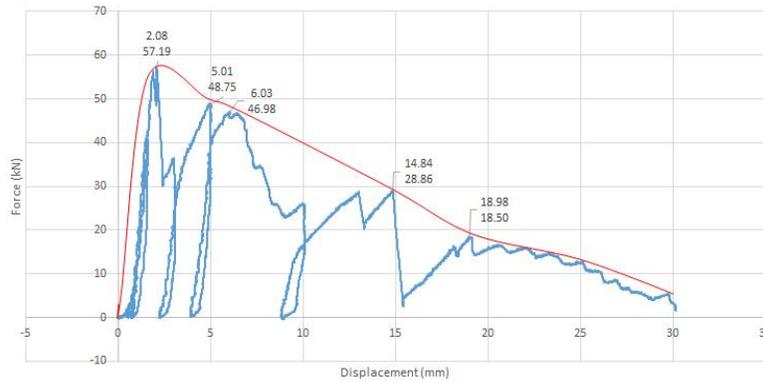
Figure 7. The force-displacement graph of the tested segment E2-1-B-L

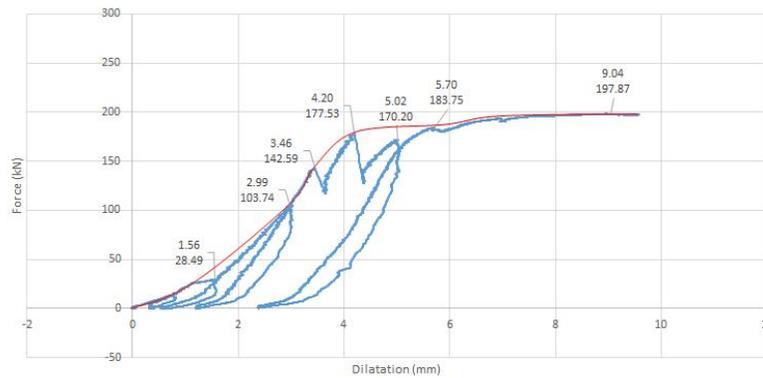
Figure 8. The force-displacement graph of the tested segment E3-1-S

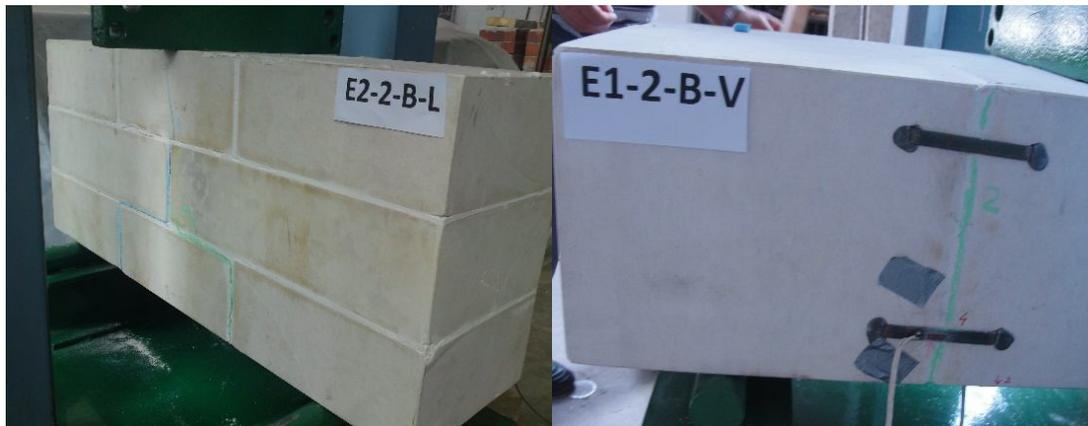
Figure 9. Occurrence of the first cracks in mortar joints

The loss of bearing capacity of the tested mortar segments for the initial loading stage was accompanied by the appearance of the first cracks (Figure 9) in mortar joints, which was registered by maximum applied force on the force-displacement graphs shown above.

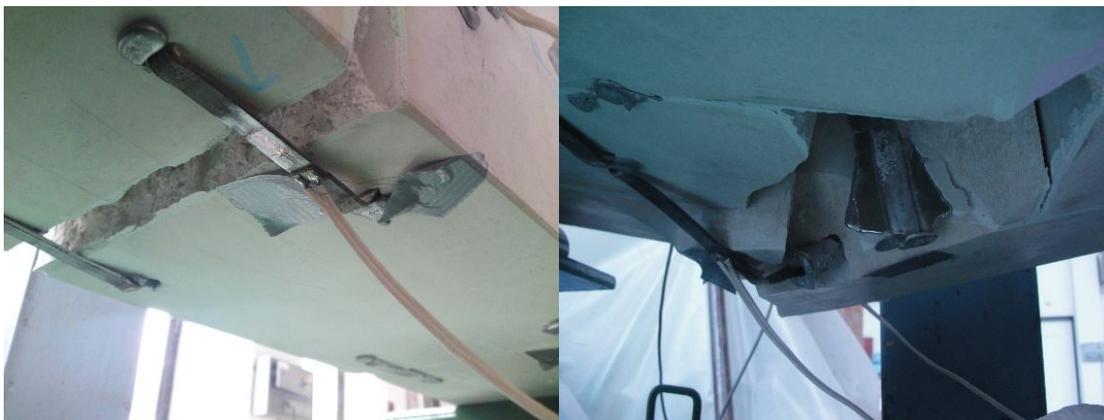
Figure 10. Cramps and dowels pulling out from their seats

Further loading is taken by connecting elements, or cramps and dowels. Failure of these connections causes gradual reduction of bearing capacity of the tested elements and the mechanism is manifested in pulling out of cramps from their seats sealed by liquid lead, followed by pulling out of dowels from their seats (Figure 10).

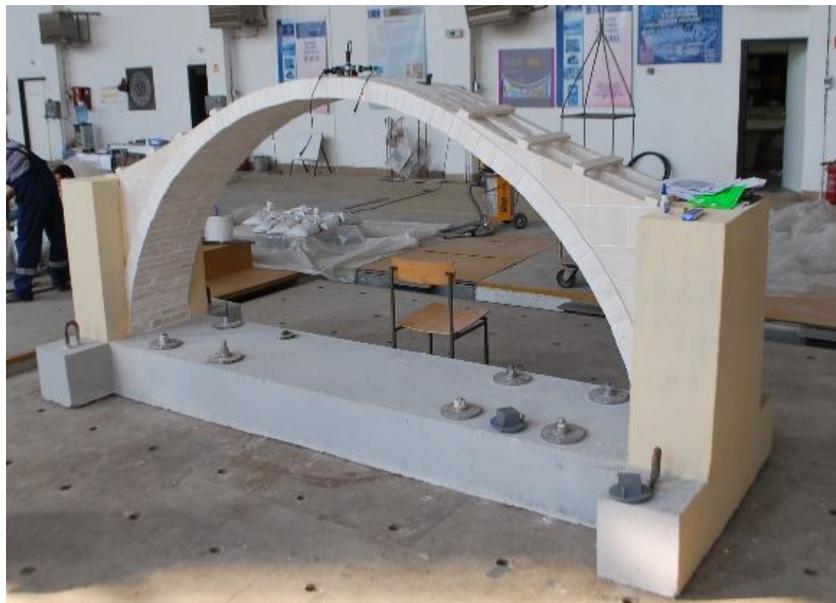
Figure 11. The model of Old Bridge at scale 1:9

The bridge model made for the second-stage experimental research was constructed as gravity force neglected model, using the materials for stone, mortar and steel connection elements of the same or sufficiently similar characteristics as in the original structure. The selected scale is conditioned by the dimensions of the shaking table – 5.0x5.0 m. Consistent with this, the total length of the tested model along with the foundation structure is 3.76m, the span of the bridge model arch is 3.16m, and the height of the model arch from the foundation to the lower point of the arch is 1.33m. The geometry according to which the bridge model was built is shown in Figure 12.

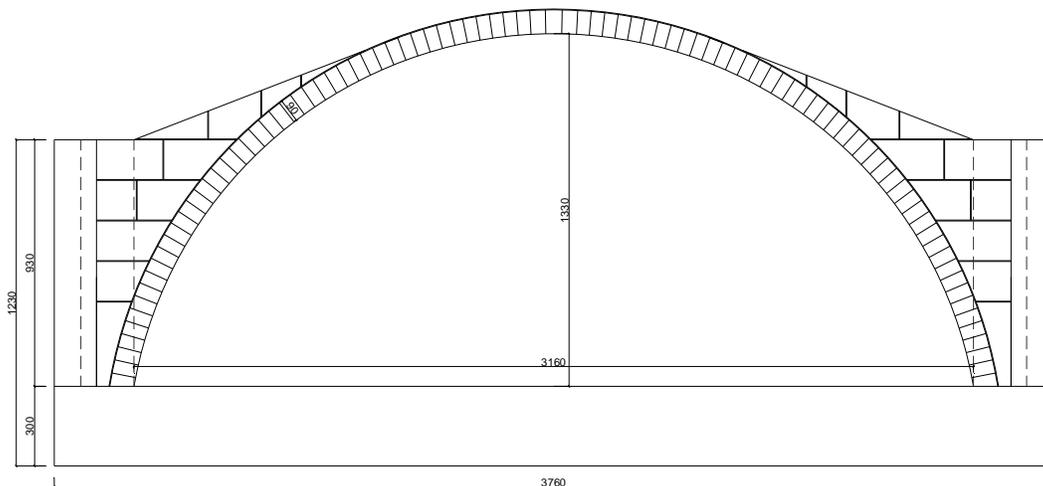
Figure 12. Bridge model geometry

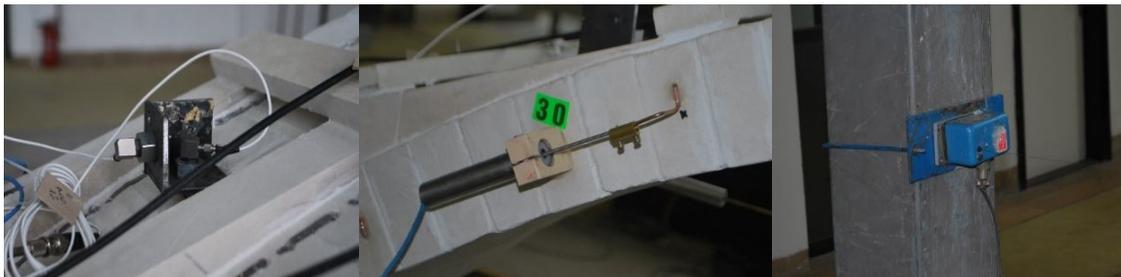
Figure 13. Accelerometer, relative and absolute displacement transducer

Preparation of the model for testing was carried out so as to include as many measurement points on the model as possible, primarily the points near the arch top and the third points of the arch. In addition to the above listed, instruments also cover points near and on the foundation structure. The testing program specifies 17 acceleration measurement

points, 11 relative displacement measurement points, and 3 absolute displacement measurement points of the bridge model (Figure 13), a total of 31 measurement point.

Accelerometers, which measured structural response in the horizontal (longitudinal bridge direction) and vertical direction, were installed as structure acceleration meters. LVDT sensors (Linear Variable Differential Transformers) were installed as structural relative displacement meters, which measured relative displacements of the arch structure or relative displacements between stone elements. LP sensors were installed on the reference pole as

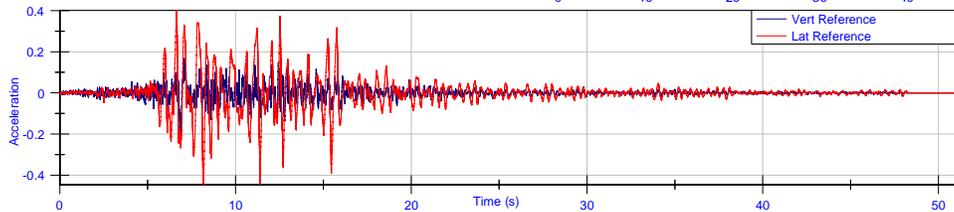
Figure 14. TH for Petrovac, SF 1:1

For seismic testing of the Old Bridge model, it was adopted to apply the accelerogram of the Petrovac earthquake from 15 April 1979, which is scaled by the factors 1:9, 1:6 and 1:3 for the purposes of bridge model testing or for excitation of bridge model vibrations in the resonant state. The excitation was applied simultaneously in the longitudinal (Y) and vertical (Z) directions.

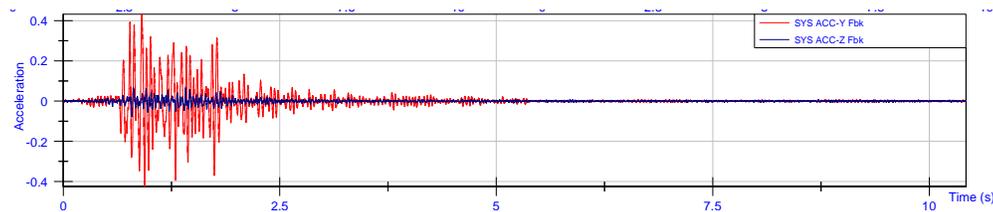
Figure 15. TH for Petrovac, SF 1:9

The scaled accelerograms of the Petrovac earthquake used for the dynamic testing of the Old Bridge model are shown on the following figures:

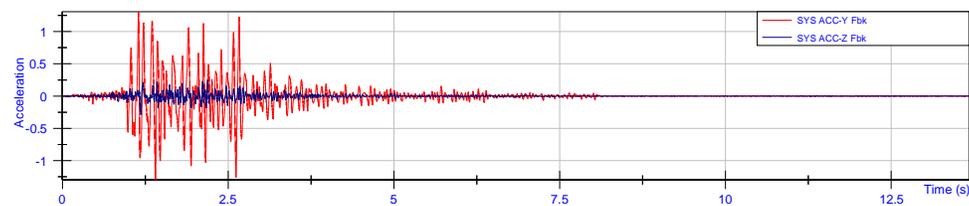
Figure 16. TH for Petrovac, SF 1:6

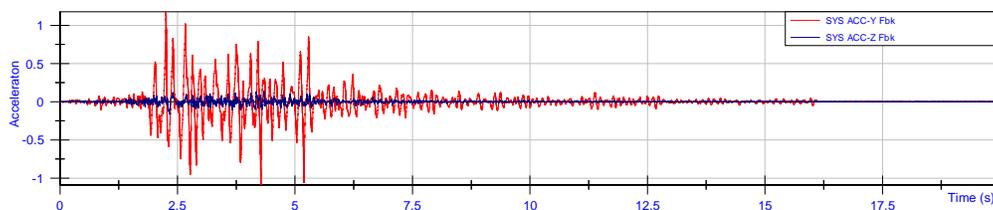
Figure 17. TH for Petrovac, SF 1:3

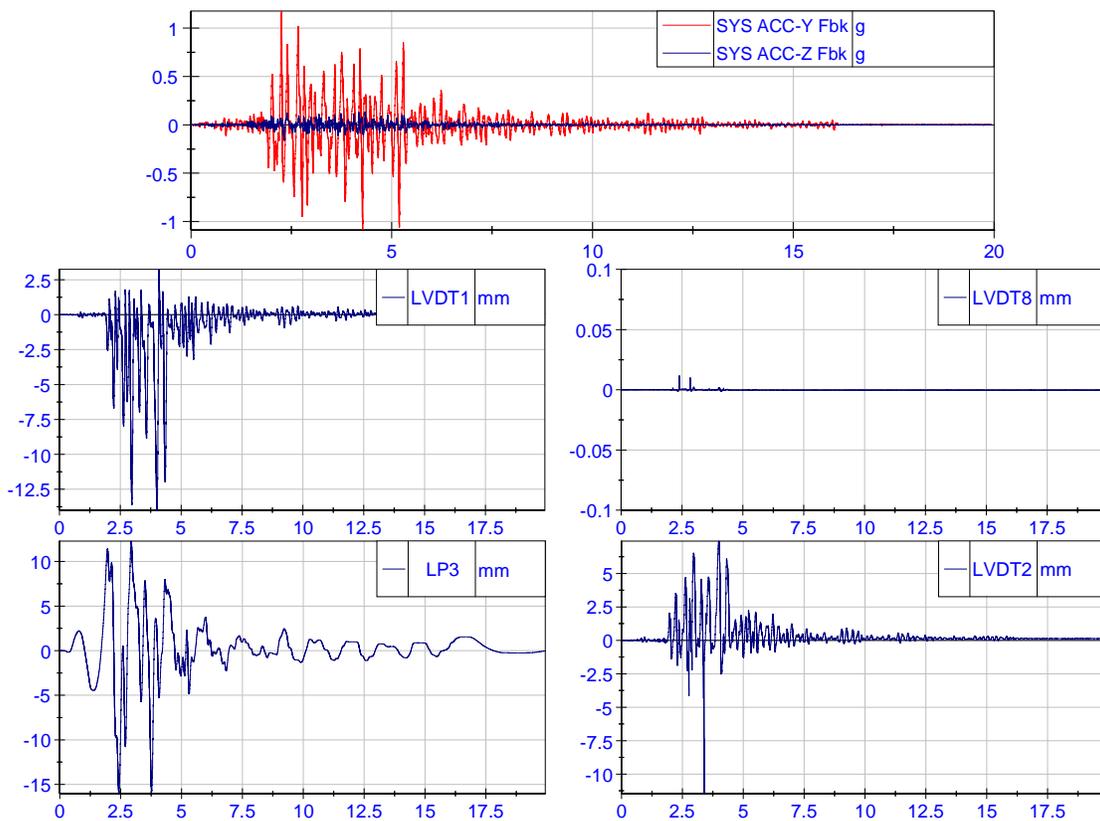
Figure 18. Input acceleration and model response at characteristic points for Test_38

The measured displacements of the bridge model for input acceleration for Test_38, for which the scaling factor is 1:3, are shown in Table 8. For the measurement point of displacement transducer LVDT1 placed at the top of the model arch, which measured vertical displacements, a displacement of 17.24 mm was measured. The displacement transducer LP3, also installed at the top of the bridge arch, measured the horizontal displacement value of 31.65 mm. For the displacement transducer LVDT8, placed on the rows 46 and 48, where it measured relative horizontal displacements, we the value of 0.01mm was read. For the measurement point of displacement transducer LVDT2, which was placed on the arch row number 69, a displacement of 18.89mm was measured.

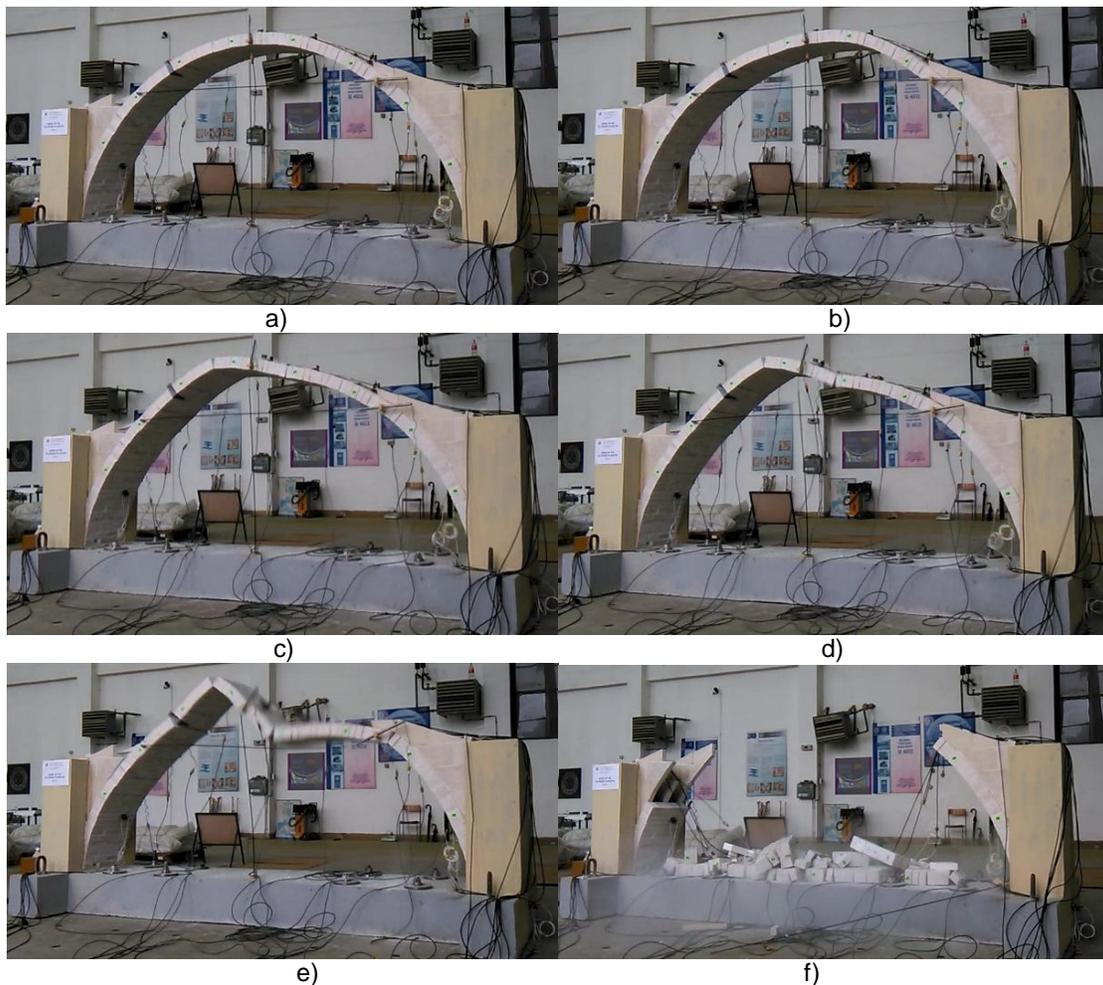
Figure 19. Bridge model failure mechanism

For the last test, marked Test_39, with input acceleration of 2.27g, scaled by the scaling factor 1:3 in the time domain, in which the model failure occurred, we can state that it is not realistic to happen for the prototype location, and it was carried out for the purpose of analyzing the behavior type and determine the model failure mechanism. The model failure mechanism shown in Figure 19 is the result of irreversible model deformations, large displacements, stiffness degradation, failure of implemented connection elements, which led to the stability loss manifested by the characteristic mode of structural failure.

Development of cracks on the bridge model confirmed that the top zone of the bridge arch and the zone of third points are the key damage points for these types of structures. The latter was confirmed by the maximum vertical and horizontal displacements measured at these places.
